# UNDERWATER BRIDGE INSPECTION REPORT

STRUCTURE NO. 7001

CASCADE STREET

OTTER TAIL RIVER

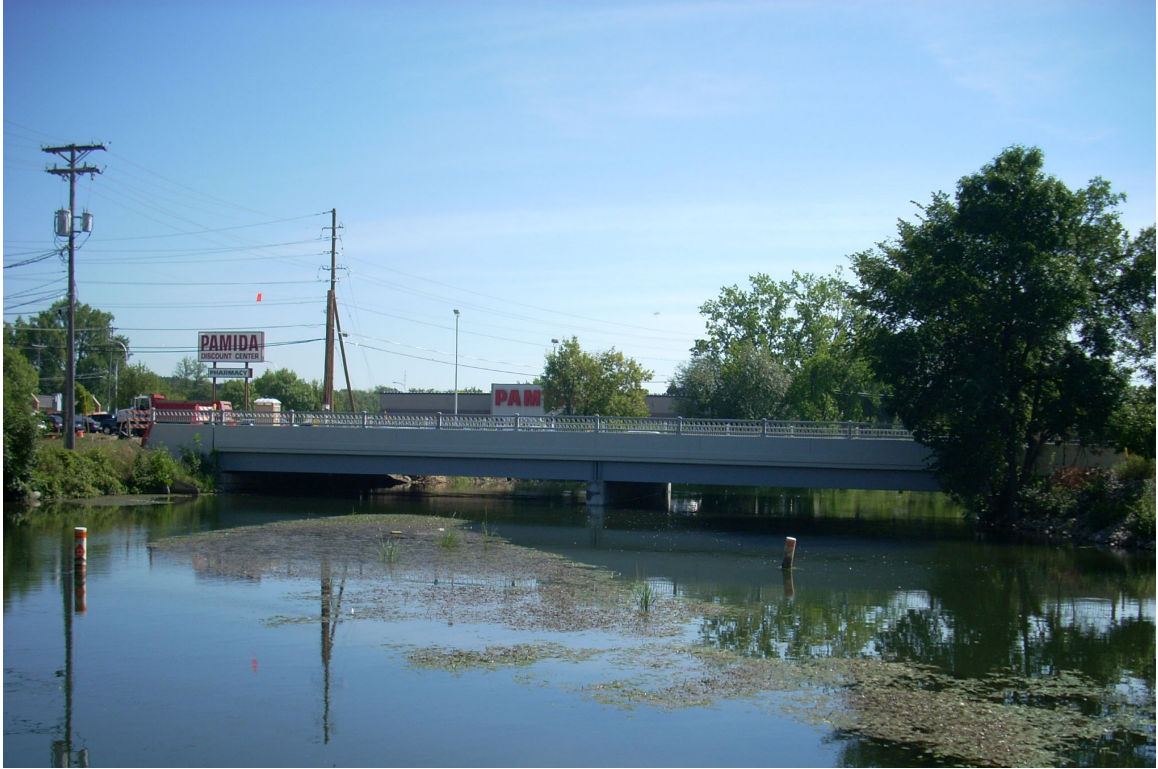
Photograph 1. Overall View of the Structure, Looking East.

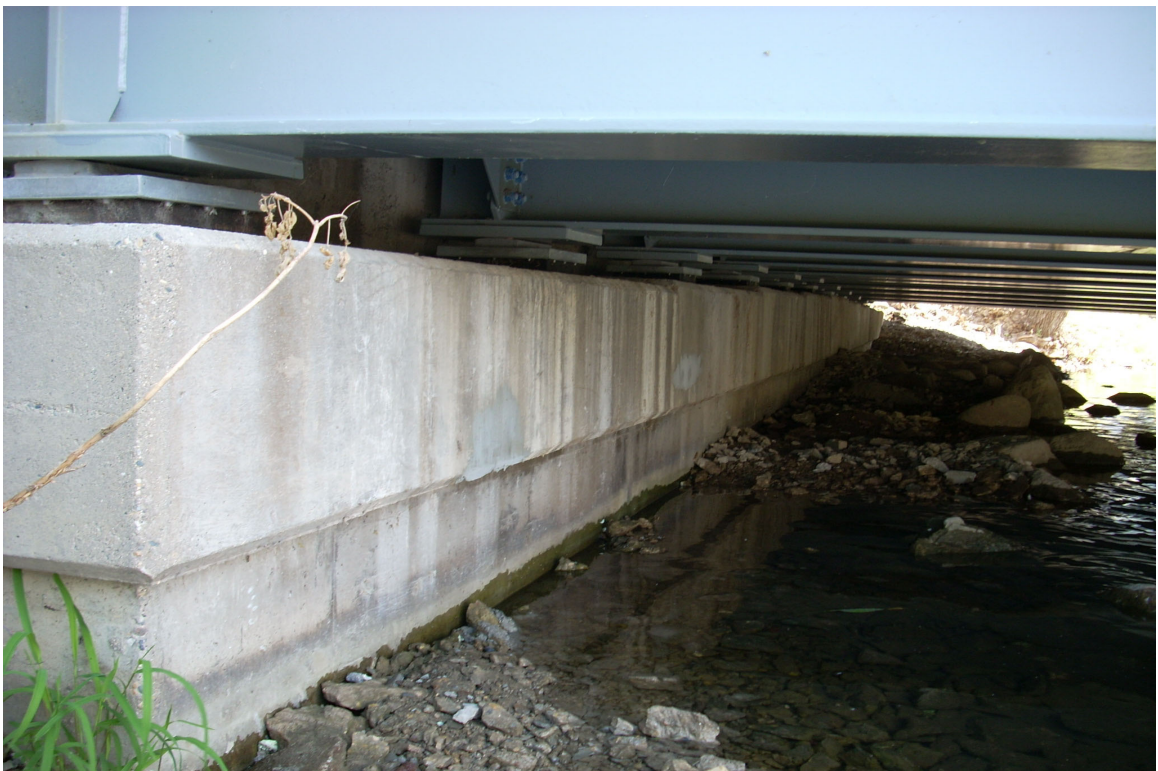
Photograph 2. View of North Abutment, Looking East.

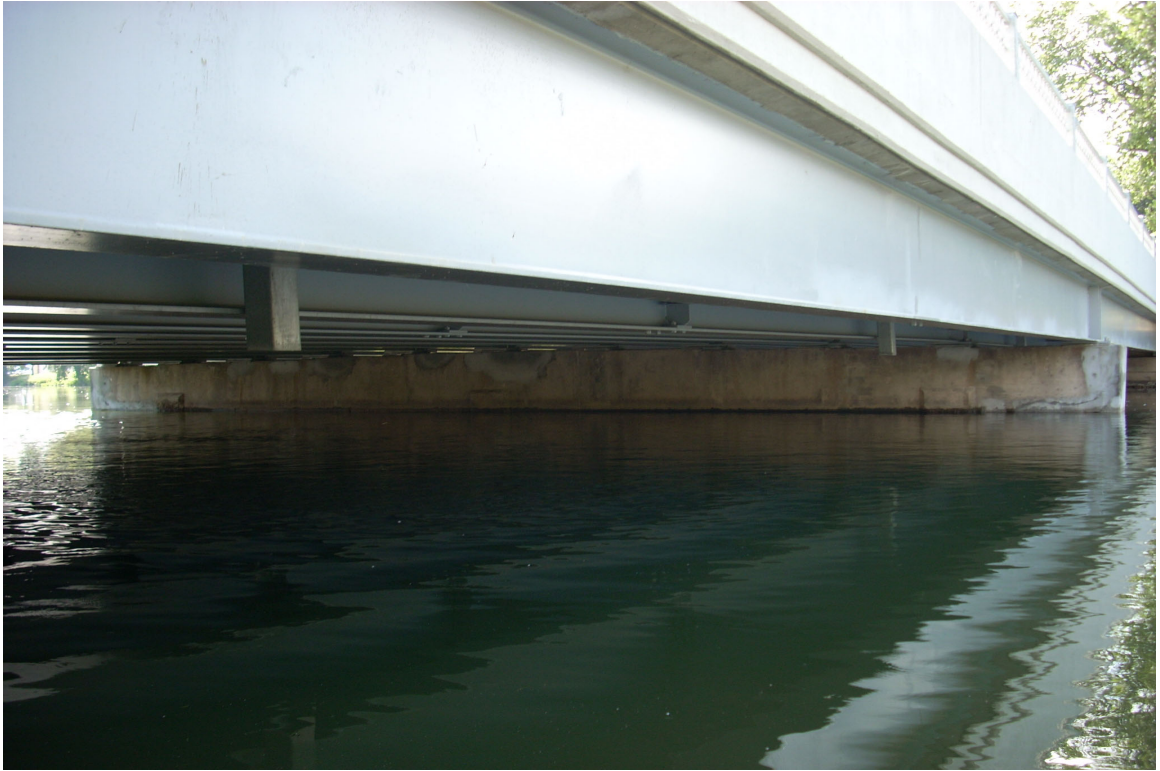
Photograph 3. View of Center Pier, Looking Southeast.

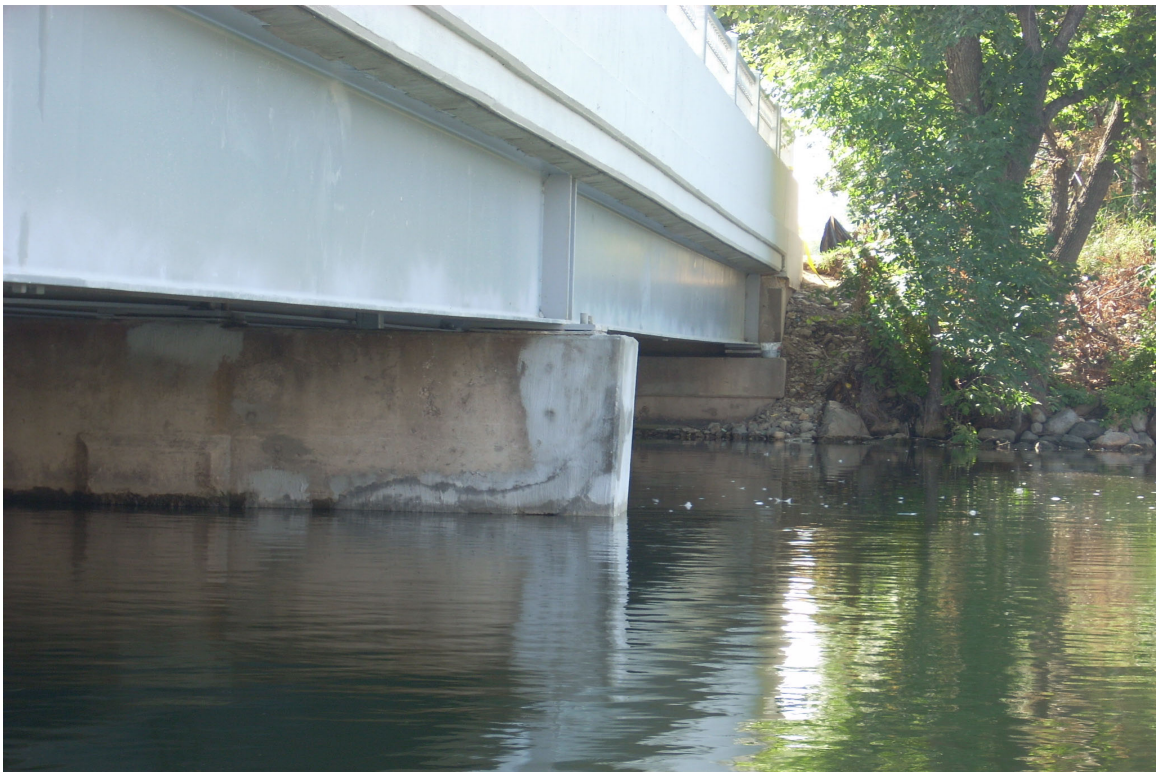
Photograph 4. View of Downstream End of the Center Pier, Looking South.

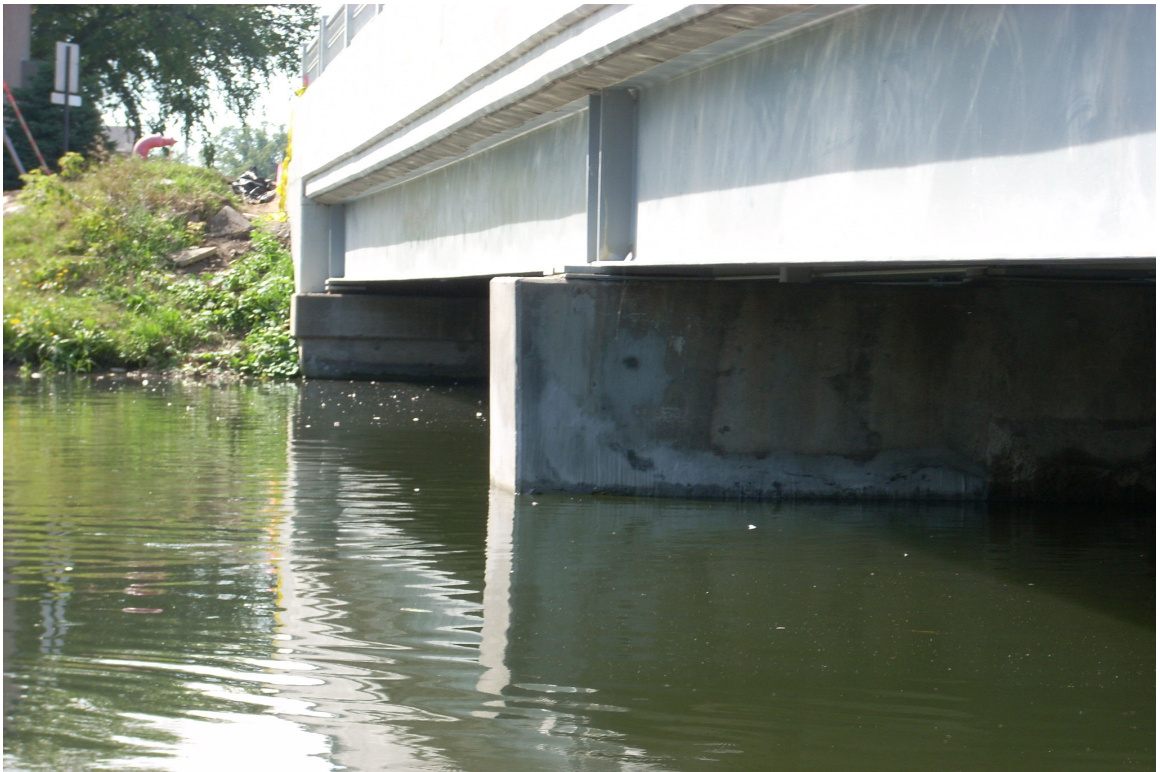
Photograph 5. View of Upstream End of the Center Pier, Looking South.

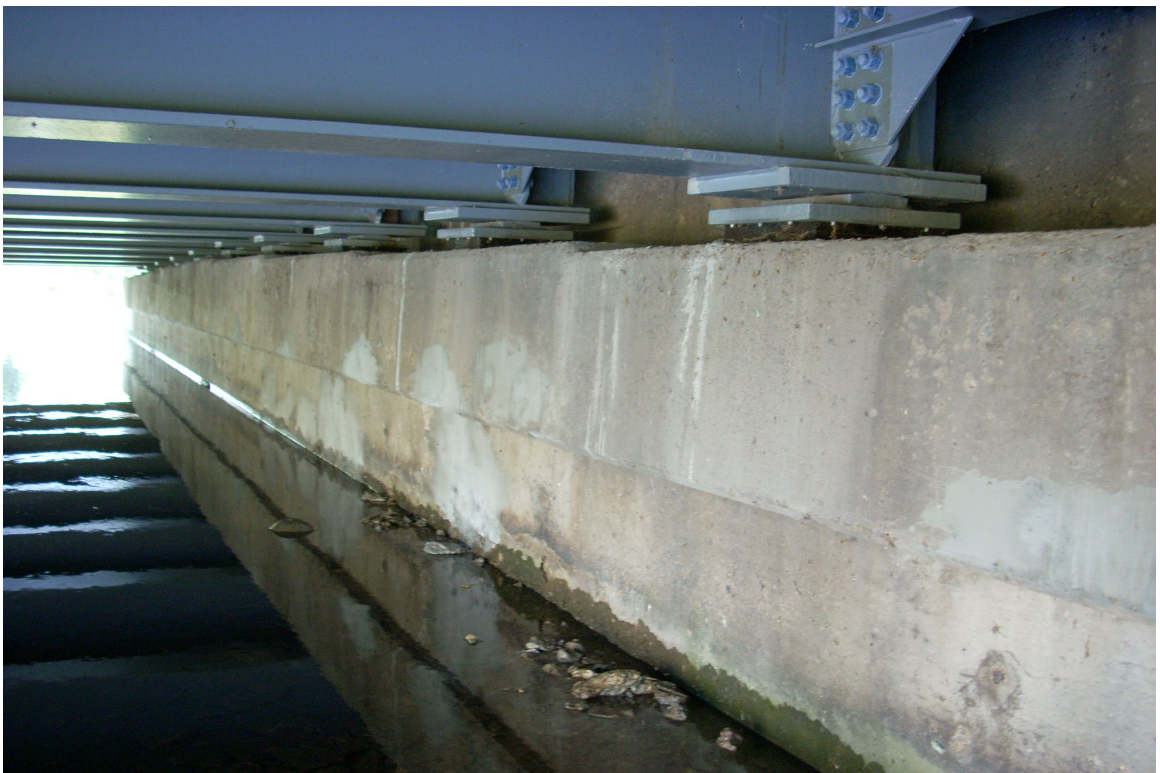
Photograph 6. View of South Abutment, Looking East.

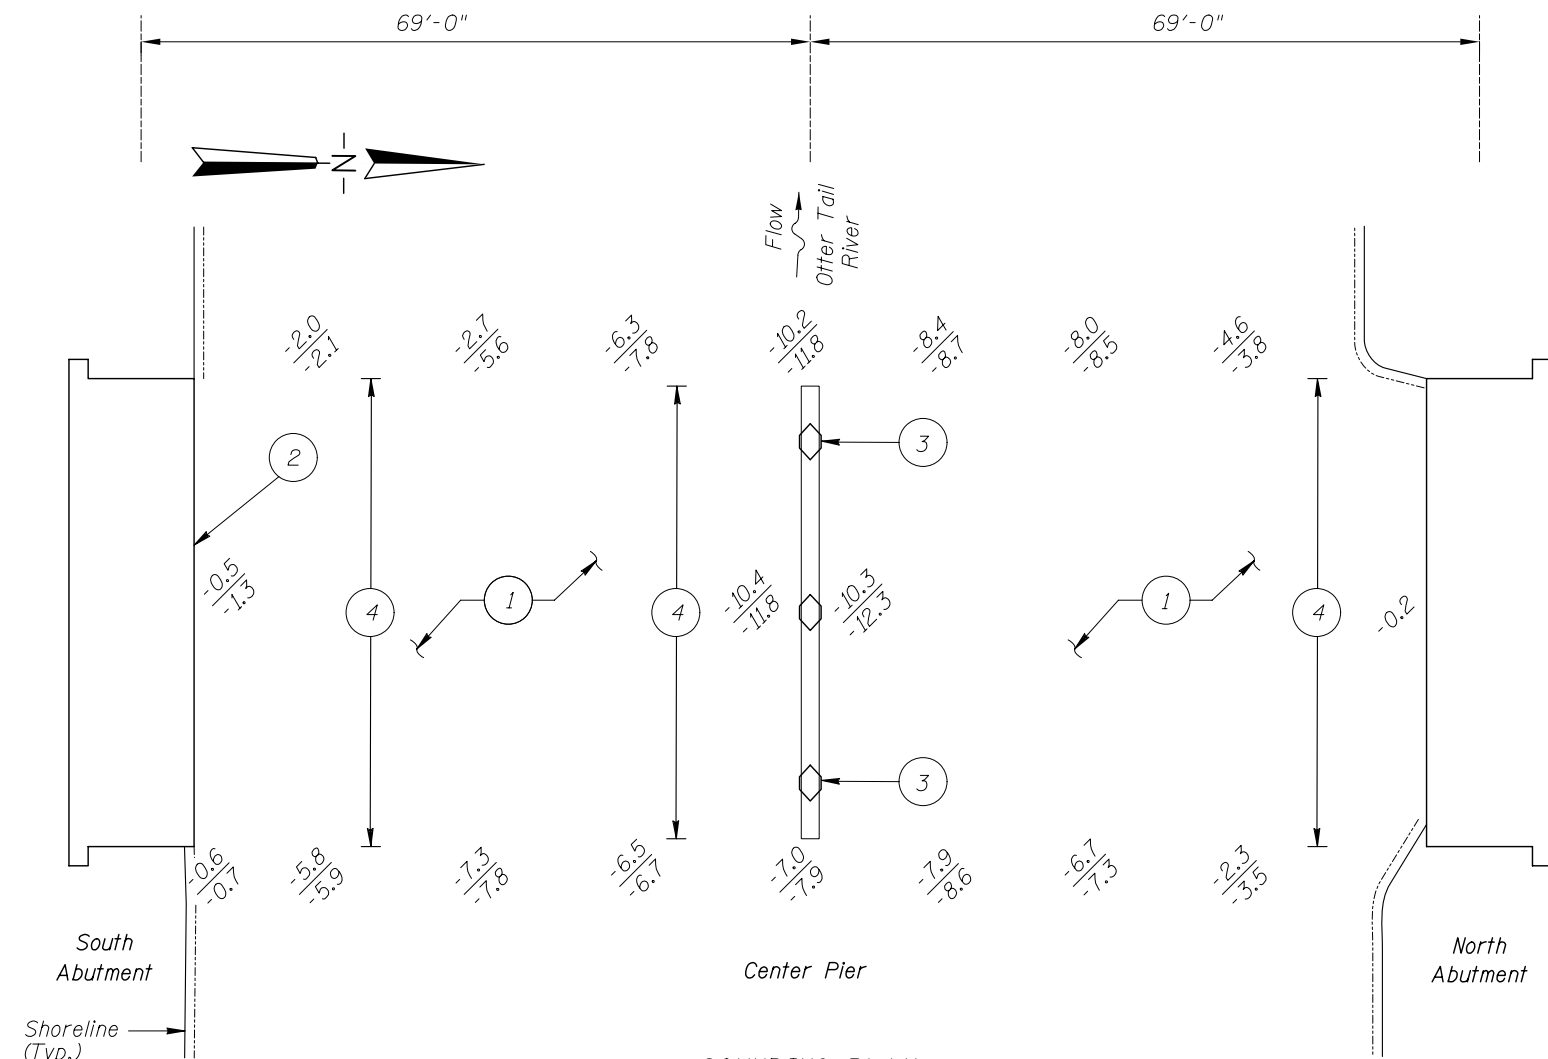
#### INSPECTION AND SOUNDING PLAN

1. The channel bottom consisted of sandy gravel with scattered riprap up to 3 feet in diameter with a probe rod penetration of up to 3 inches.
2. The downstream 1/4 point of the South Abutment exhibited moderate scaling from 1 foot above the waterline to the channel bottom with up to 1/2 inch of penetration. The abutment also exhibited minor areas of poor consolidation up to 1/2 inch penetration.
3. A band of scaling 1 foot high, 3 feet long and 1/2 inch deep was observed at the waterline on both the upstream and downstream columns. Areas were located where the columns meet the pier cap on both sides of the Center Pier.
4. Concrete was smooth and sound with minor areas of poor consolidation up to 1/2 inch penetration.
